TECHNICAL REPORT GL-87-14

SEISMIC STABILITY EVALUATION OF FOLSOM DAM AND RESERVOIR PROJECT

Report 2 INTERFACE ZONES

Geotechnical Laboratory

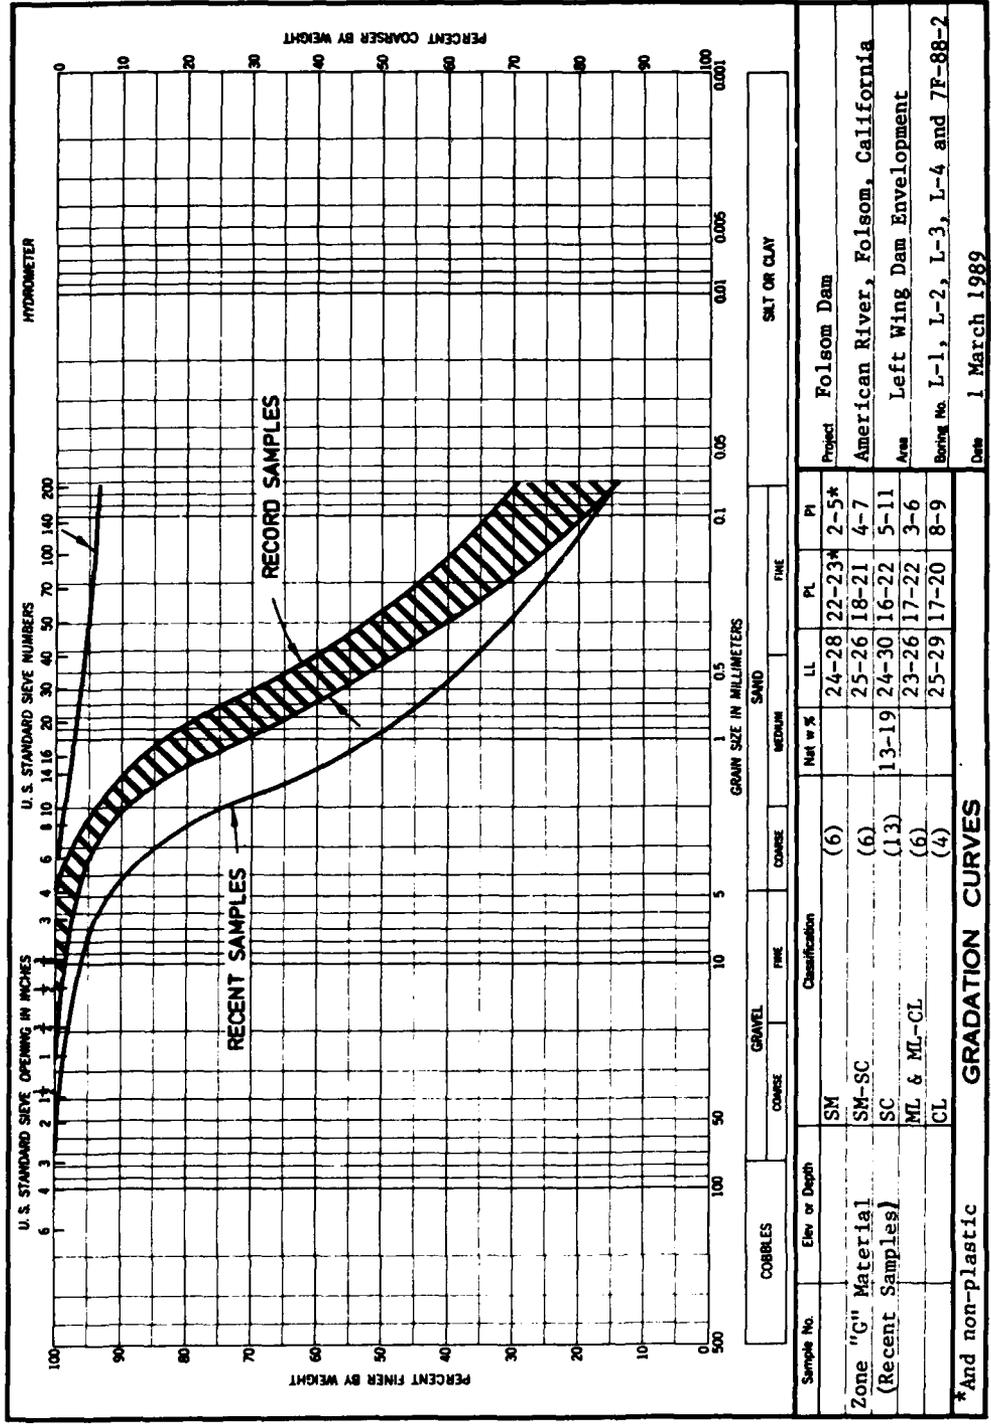
Figure 51. Comparison of ranges in grain size distribution of core material at LWD interface zones

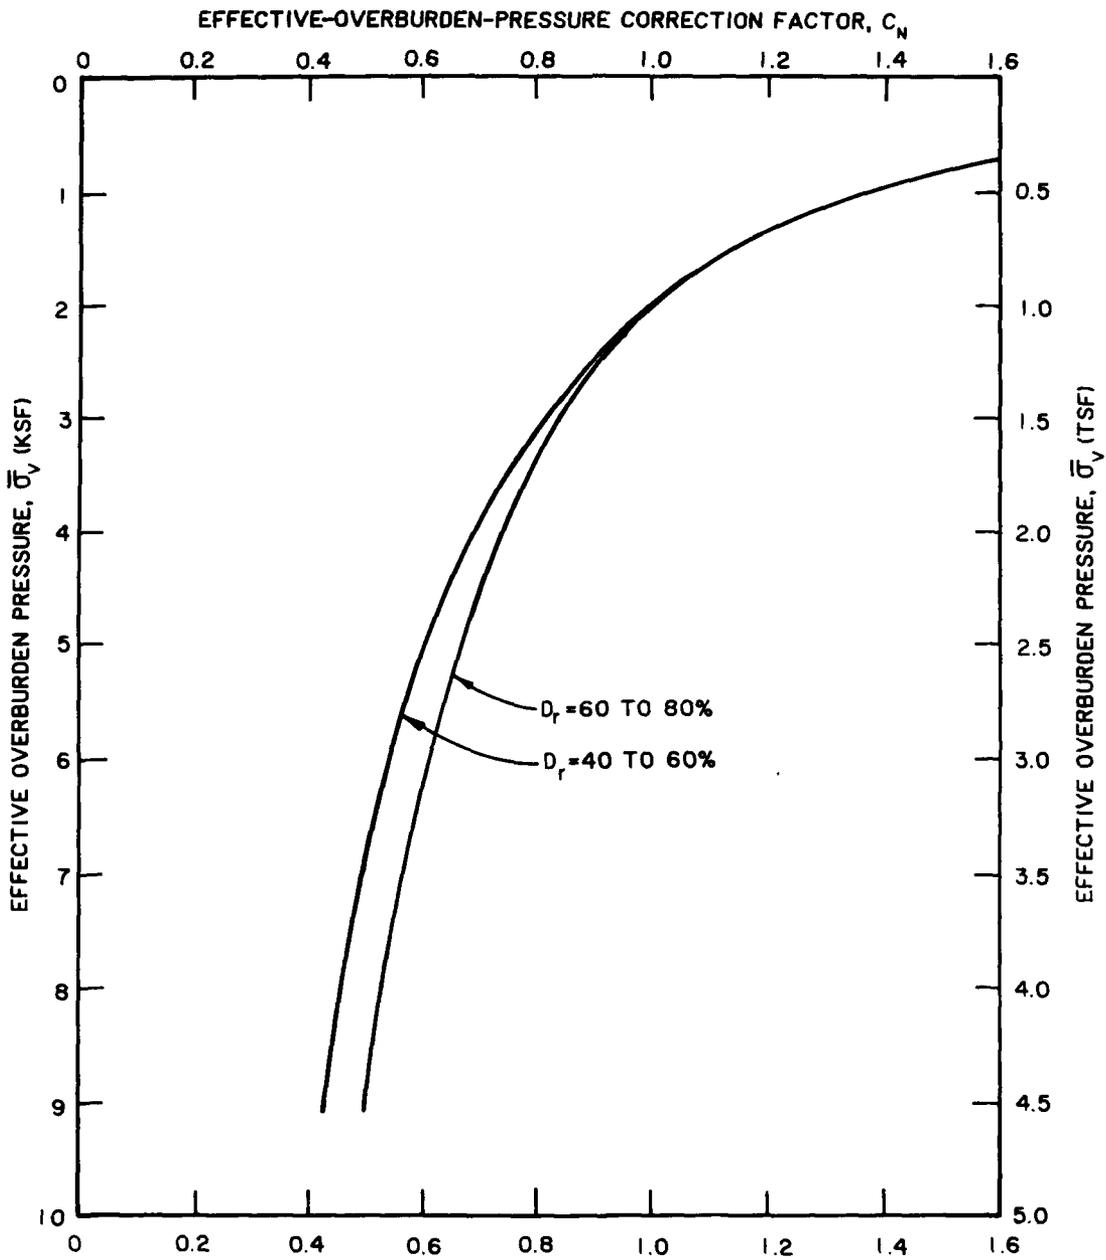
Figure 52. Empirical relations used to determine effective-overburden-pressure correction factors for SPT N or N_{60} -values

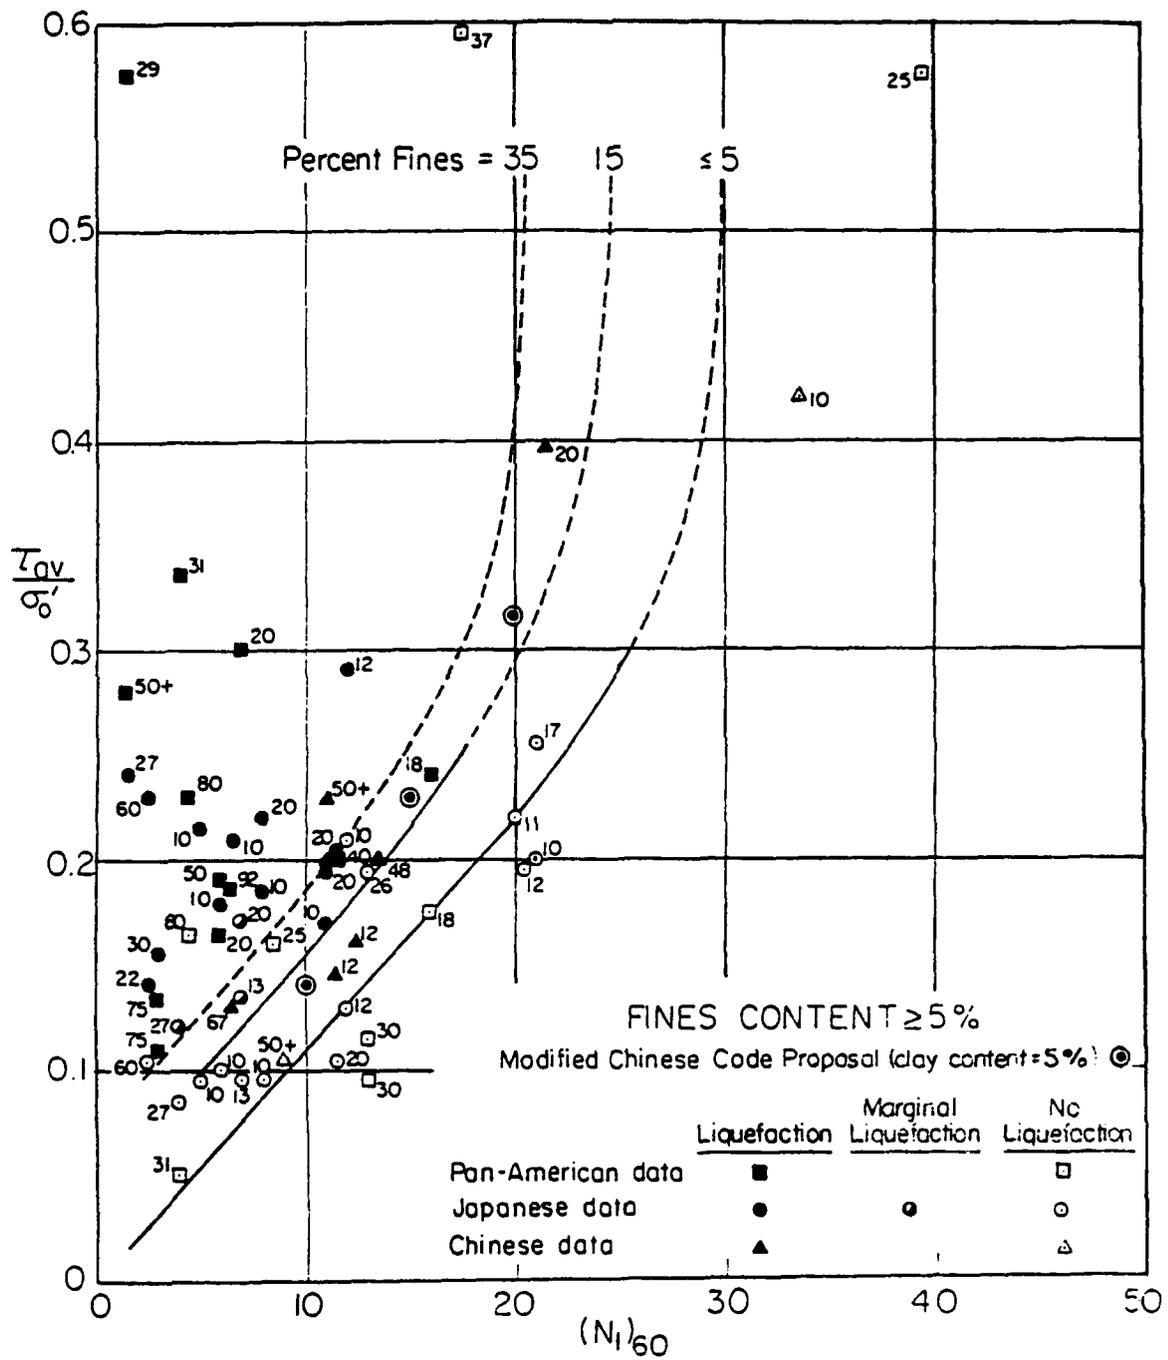
Figure 53. Relationships between stress ratio causing liquefaction and $(N_1)_{60}$ -values for silty sands for $M = 7\text{-}1/2$ earthquakes (from Seed et al. 1985)

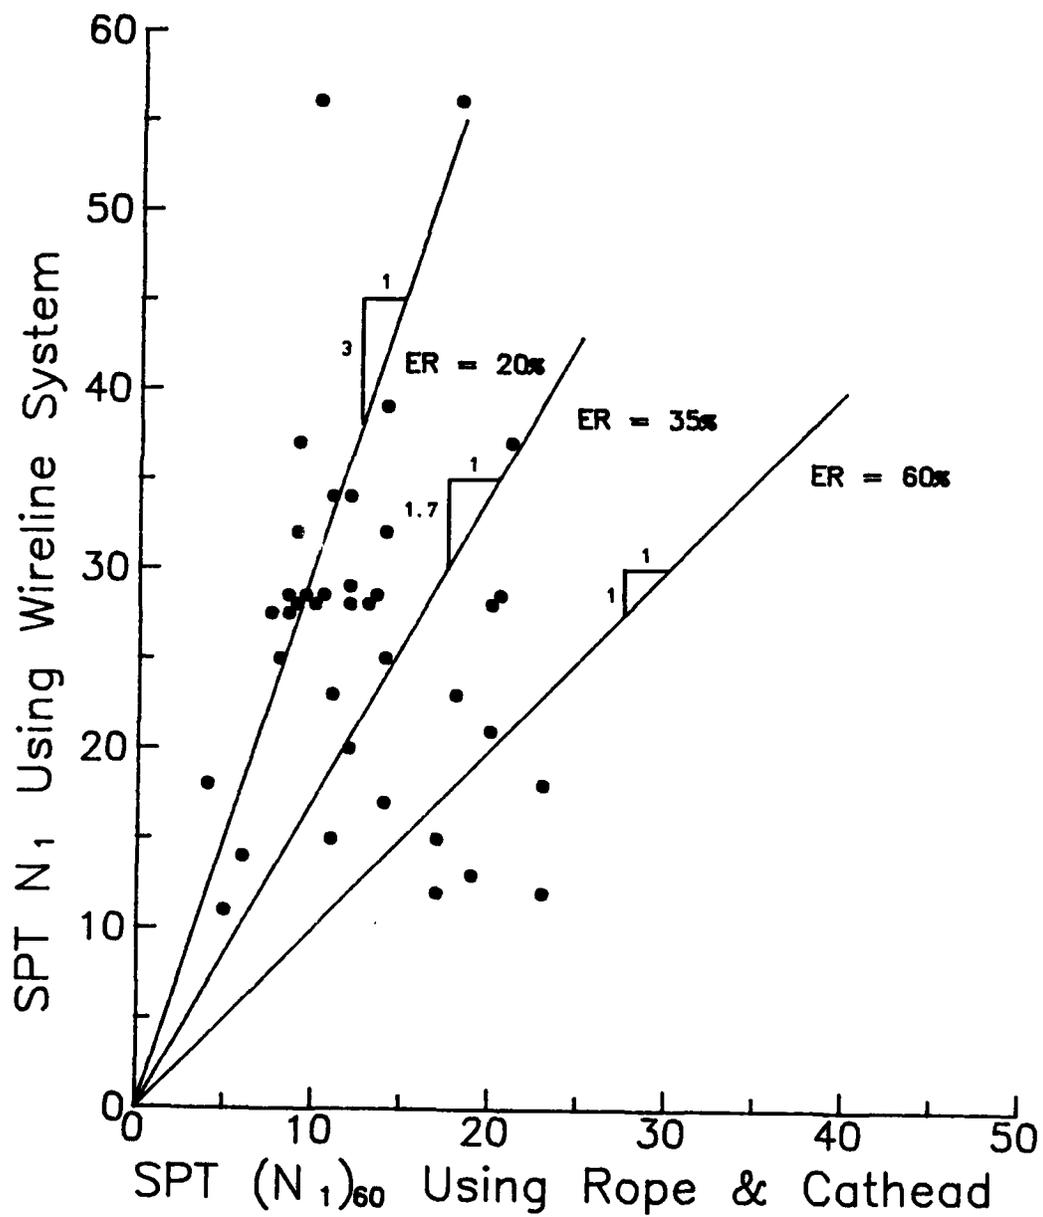
Figure 54. Comparison of blowcounts measured using rope-and-cathead and wireline systems at equal depths

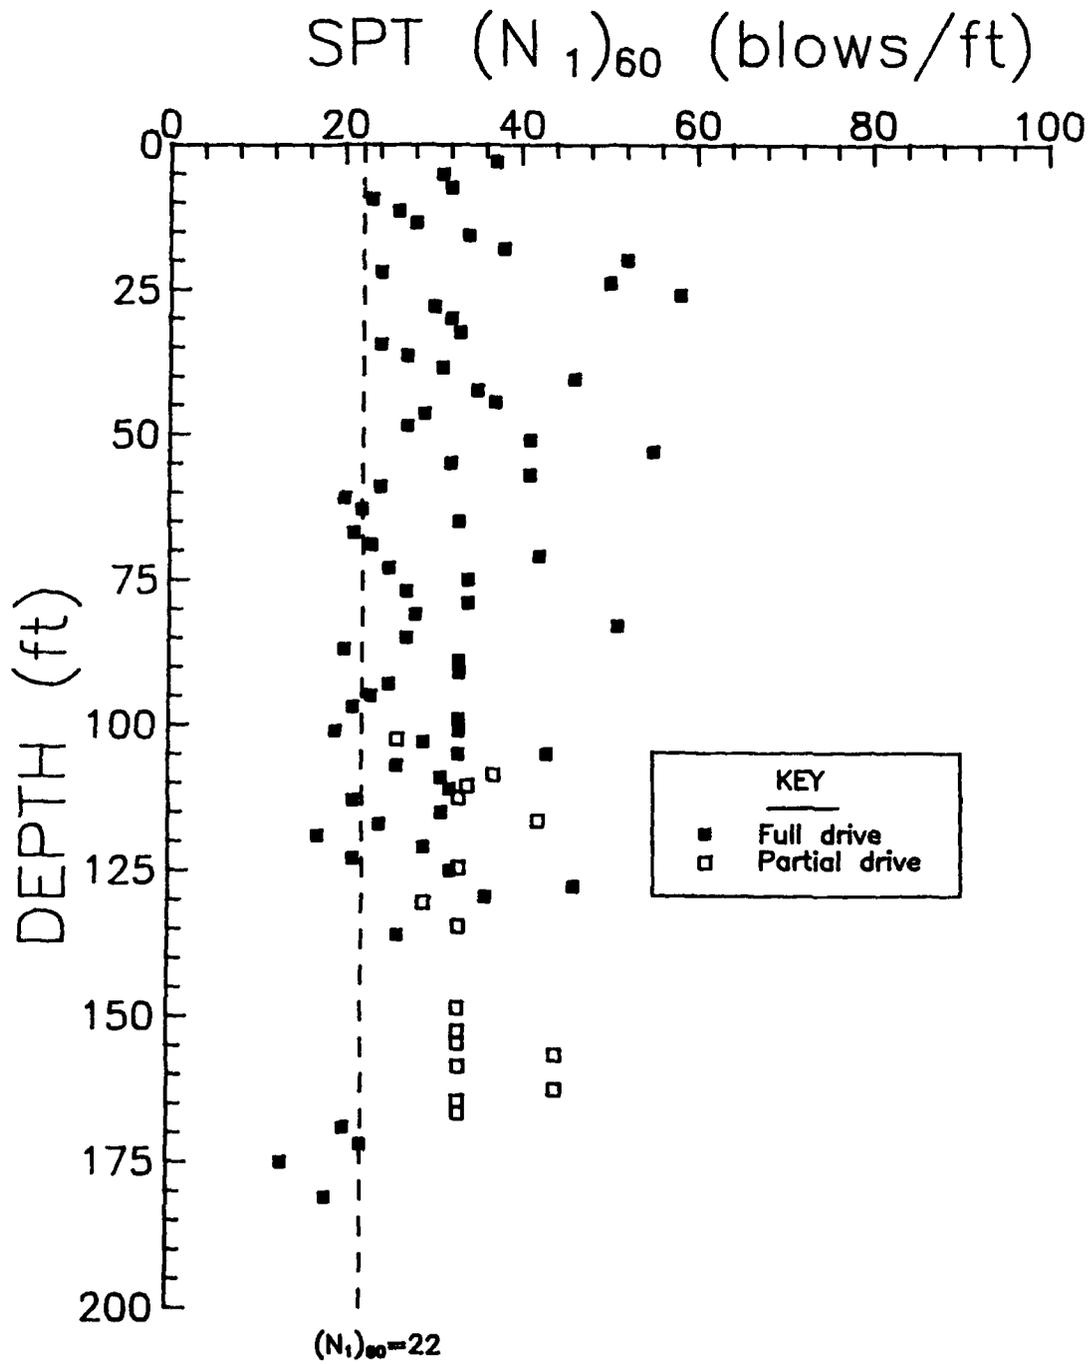
Figure 55. Results of Standard Penetration tests at RWD interface zone modified to represent an equivalent energy of 60 percent and an effective overburden stress of 1 tsf

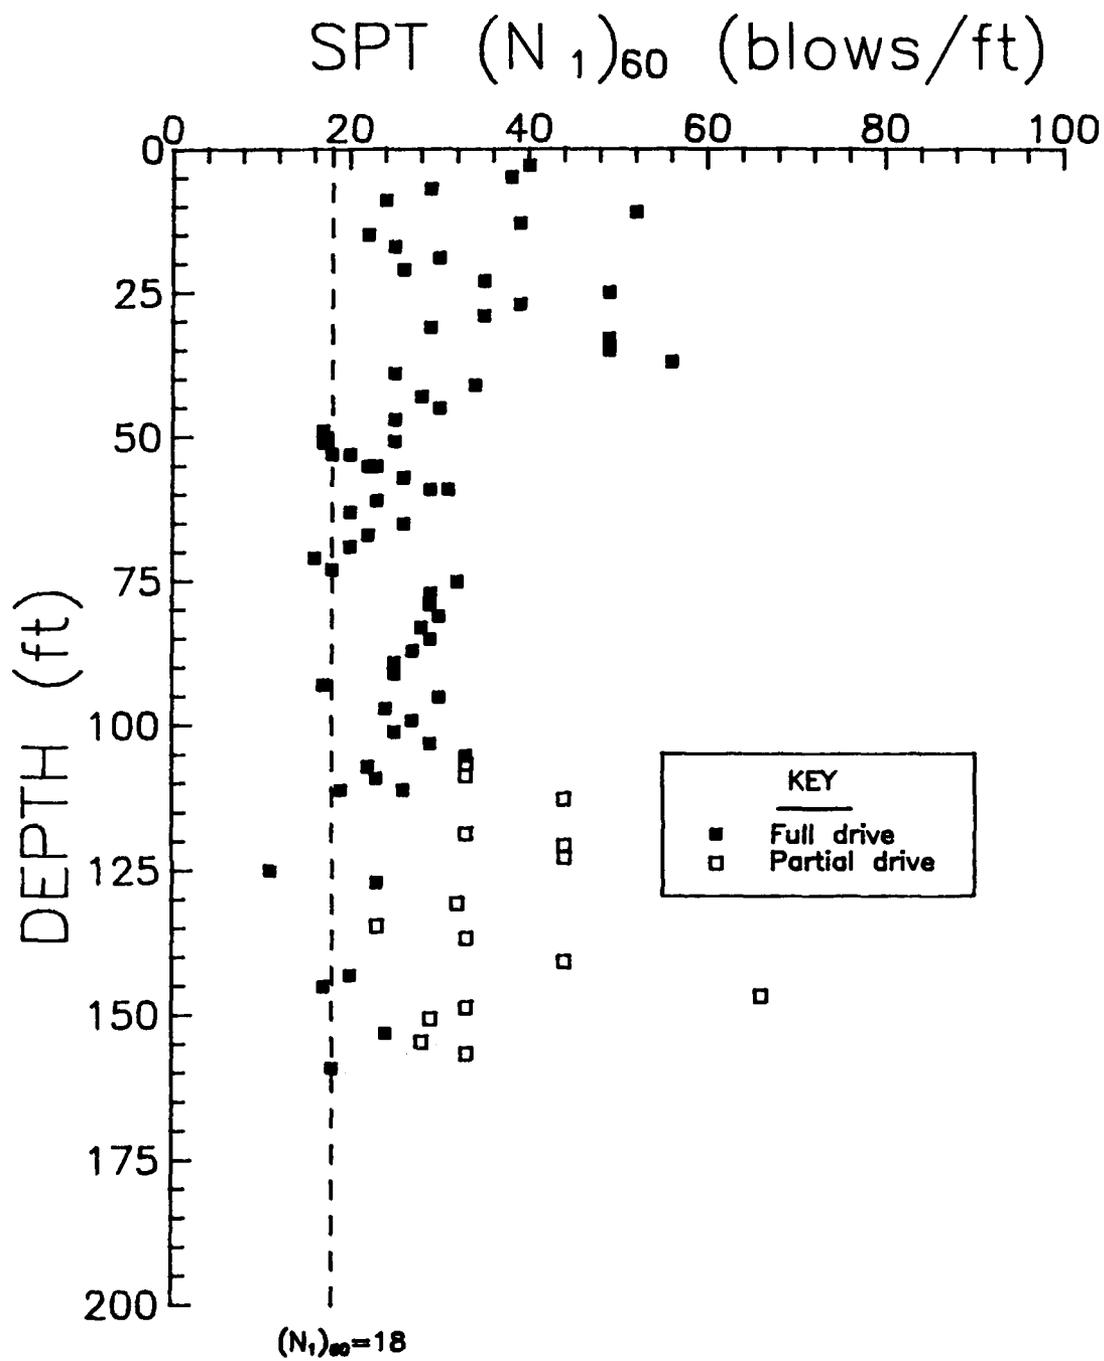
Figure 56. Results of Standard Penetration tests at LWD interface zone modified to represent an equivalent energy of 60 percent and an effective overburden stress of 1 tsf

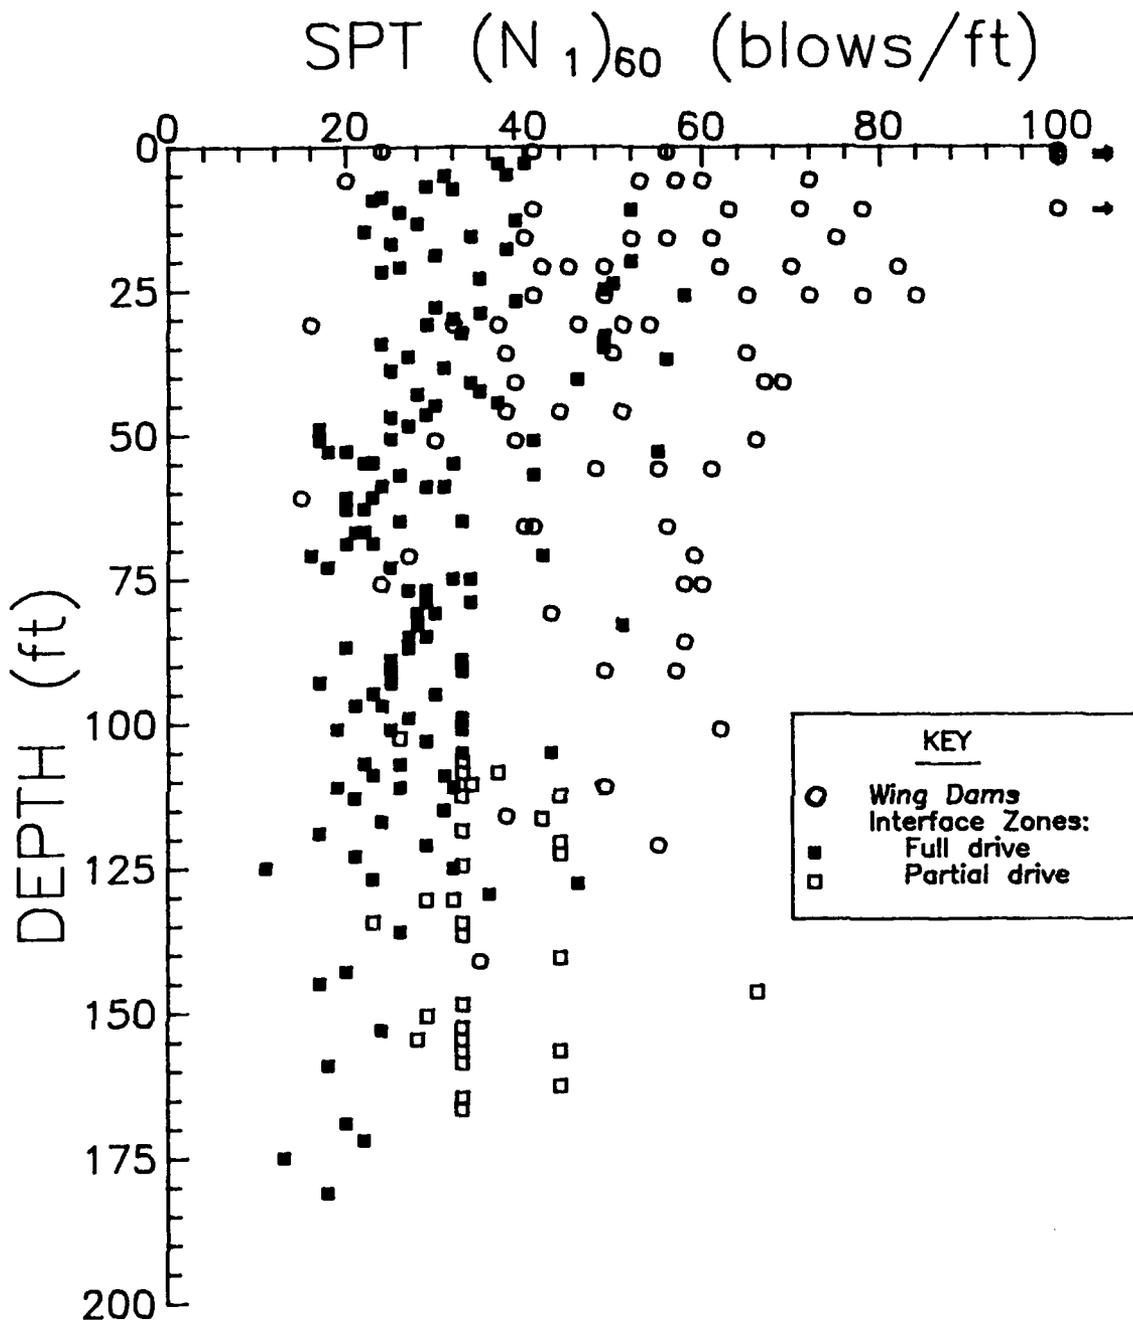
Figure 57. Comparison of $(N_1)_{60}$ for SPT's performed at interface zones and other wing dam locations

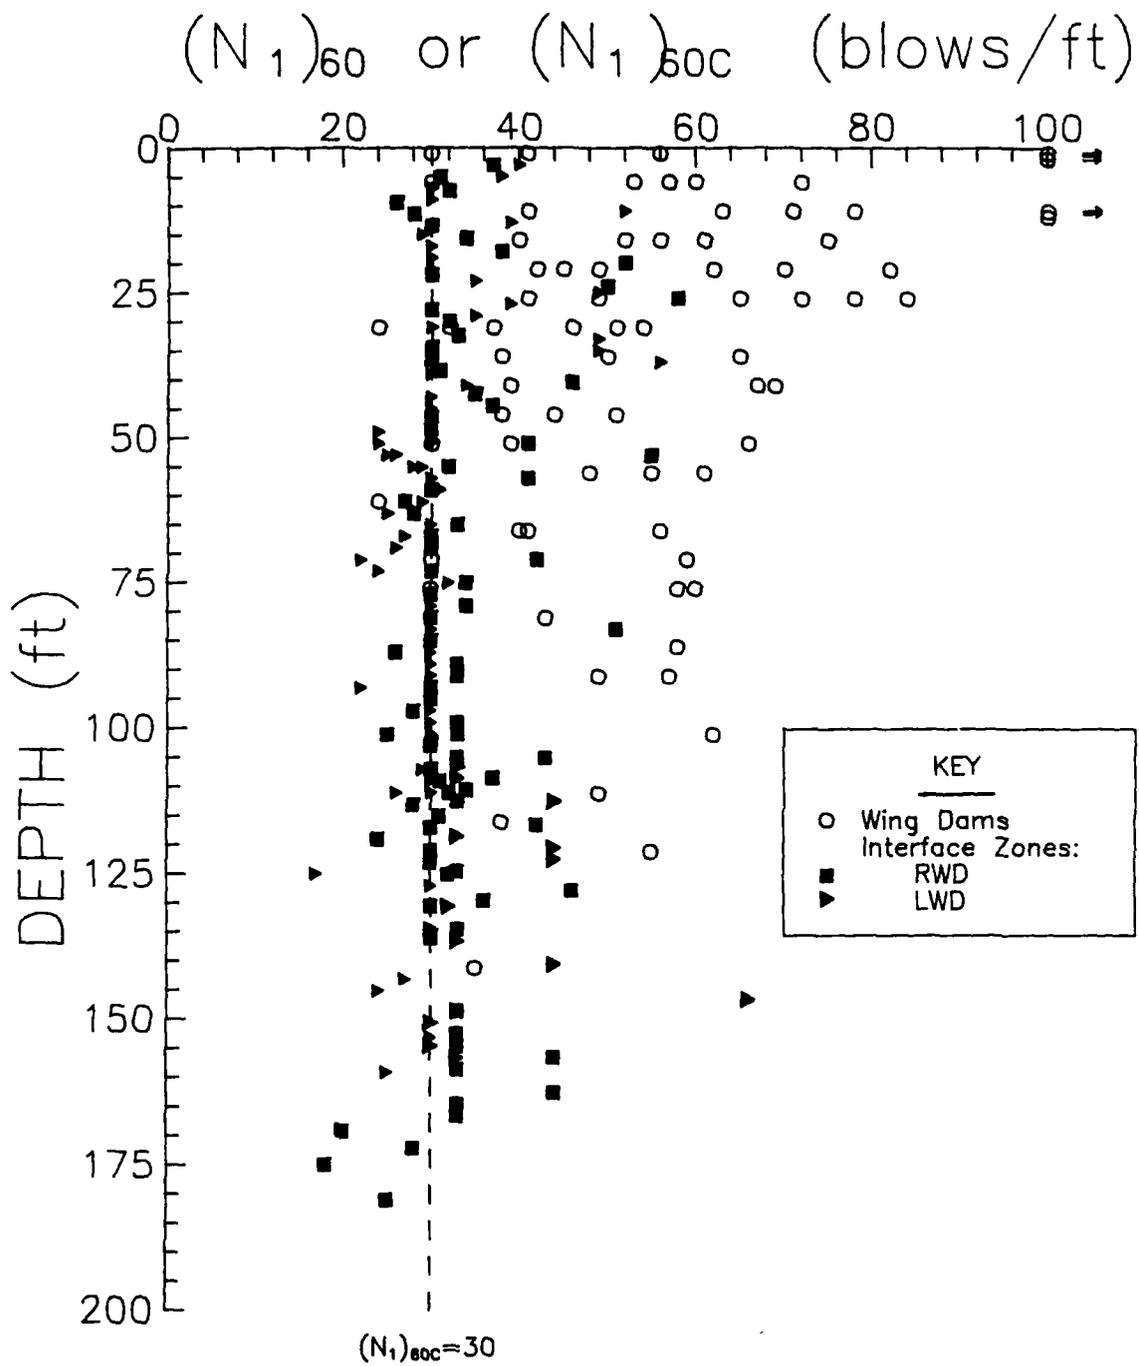
Figure 58. Comparison of $(N_1)_{60c}$ for SPT's performed at interface zones and other Wing Dam locations
